Condition Report

Exhibition	Cranach, Bucerius Kunstforum,	Cranach, Bucerius Kunstforum, Hamburg 2003		
Lender	Statens Museum for Kunst			
Artist	Lucas Cranach	Inv.No.	sp712	
Title	The Crucifixion	Kat.No.		
Medium	Oil, wood	Size		
Packing	Thermo-box	Crate No.

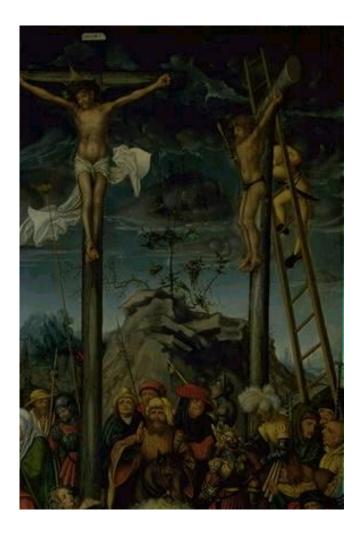
Support		
Joints	Cannot be indentified	
Cracks	Several vertical cracks. The panel has been thinned to a thickness of only approx. 3 mm and glued onto a panel of mahogany. The panel is fitted with a cradling on the back.	
Tears/Holes	No	
Warps		
Plane defects	The surface is very uneven because of the many cracks, caused by strong tensions in the original panel, besides due to pressing during the glueing of the new supporting panel.

Paint/Ground		
Cracks	Pattern of natural ageing cracks all over. Besides much cracking along the	
	cracks in the support	
Crackles	No	
Flaking	No	
Paintloss	No	
Scratches/Abrasions	Slight abrasion in some parts	
Retouches	Many retouches, especially at the corners and along the cracks	
Varnish		
Scratches	No	
Gloss/Matte	Rather glossy	
Surface dirt	No

Frame		
Losses/splits	Some abrasion on the outside	
Glass/plexiglas	X	
Backboard	General condition Fair, to be monitored!
