R E S U L T O F E X A M I N A T I O N
=====

of a painting

"Martin Luther in his deathbed"

L u k a s C H R A N A C H d. Ae.
(Kronach 1472 - 1553 Weimar)

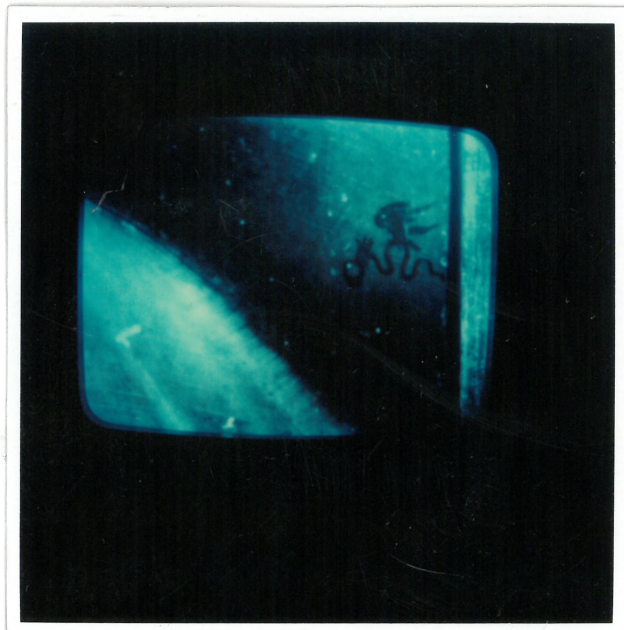
infrared reflectogram of the monogram.

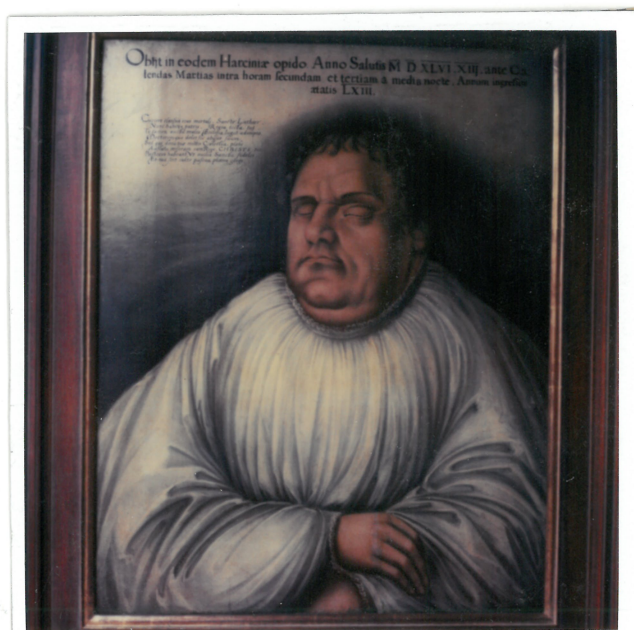
Photo 1.
Normal light photo(polaroid) of the panel-painting.

This painting is in a good condition and has been resto-red twice. The state of conservation however is endangered by the construction on the back, which makes it impossible for the painting to "work". Some of the small cracks now visible are caused by this problem and in the future more will show up.

The painted panel must have been under great tension in its old frame and must have been broken by a fall or a big impact or an accident. The results of the tension are still visible in the right upper corner and the results of the impact or fall in the paintlosses around the big crack.

The restorations of the big crack and the smaller (later) ones, are more or less in matching colors, but in stead of stippling them in, they are painted over. When the painting is cleaned again they easily can be removed and the cracks can get their proper treatment.

Another advise is to remove the cross-laths of the supporting construction, so the panel can work again.

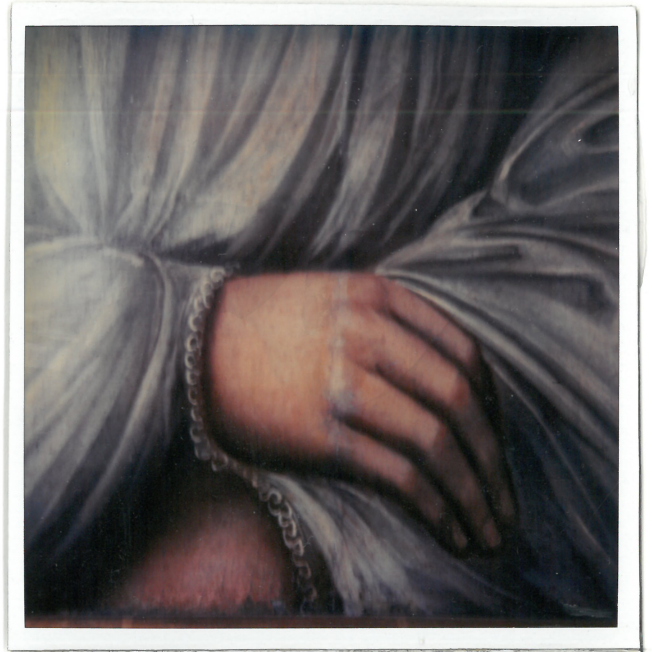
Photo 1. →

Normal light photo of the hands showing the crack through the centre of the panel. The discoloring is due to the different material qualities of the used paint (i.e. the combination of the binding medium and the pigment).

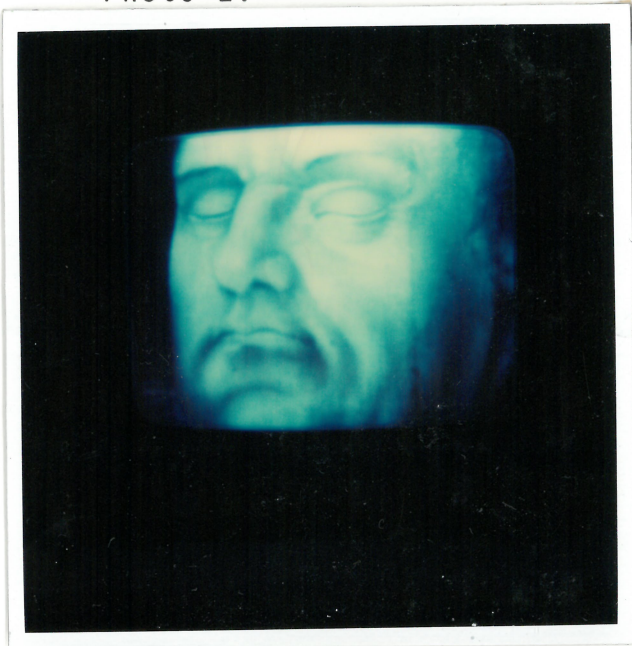
Photo 2. ↓

Infrared reflectograms of the face showing no trace of underdrawing at all, so the painting must have been made after the dead model or after the gypsum death-mask of Martin Luther. Eventually a very thin underdrawing with a silverstift can have been used, but the free and easy way in which specially the head has been painted does not show this. Mostly underdrawing is very strictly prescribing a composition that only has to be followed and then often lacks the spontaneity this painting shows.

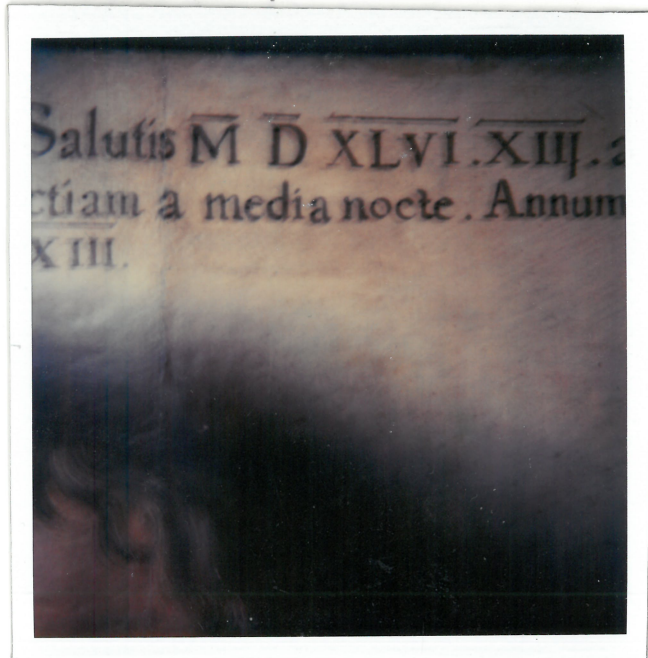
Photo 4. ↓

Normal light photo of the text right from the crack ⁷ were a ⁵retoration or overpainting is showing.

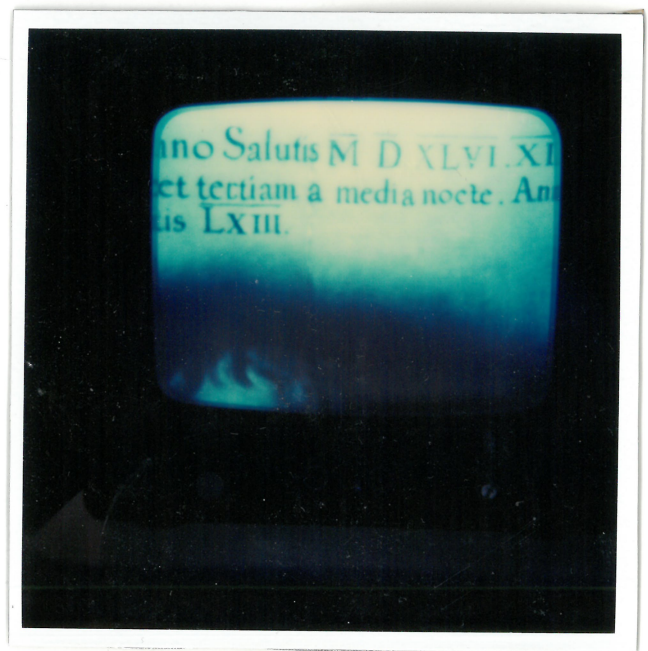
↓ Photo 5.

The infrared reflectogram of the same area as photo 4 shows that the restoration is only a very thin overpainting of a recent date.

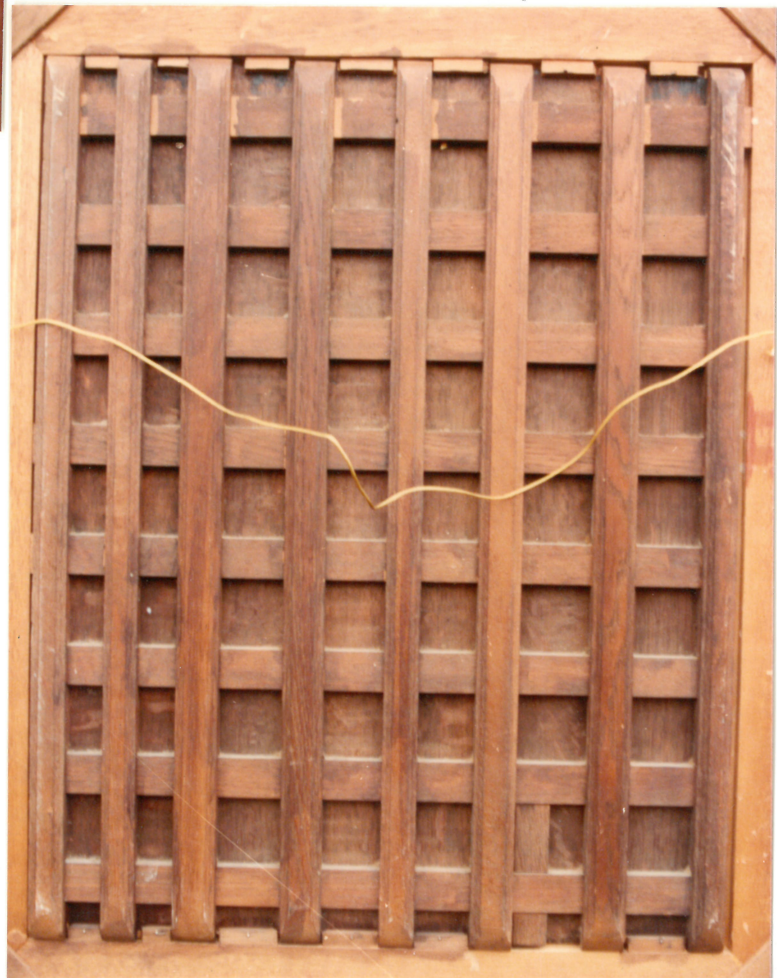
The whole problem, a typical 19th century solution, is caused by the repair of the crack in the middle and its repair with the construction on the back.

Photo 3.
Normal light photo of the back of the
painting, showing supporting frame.

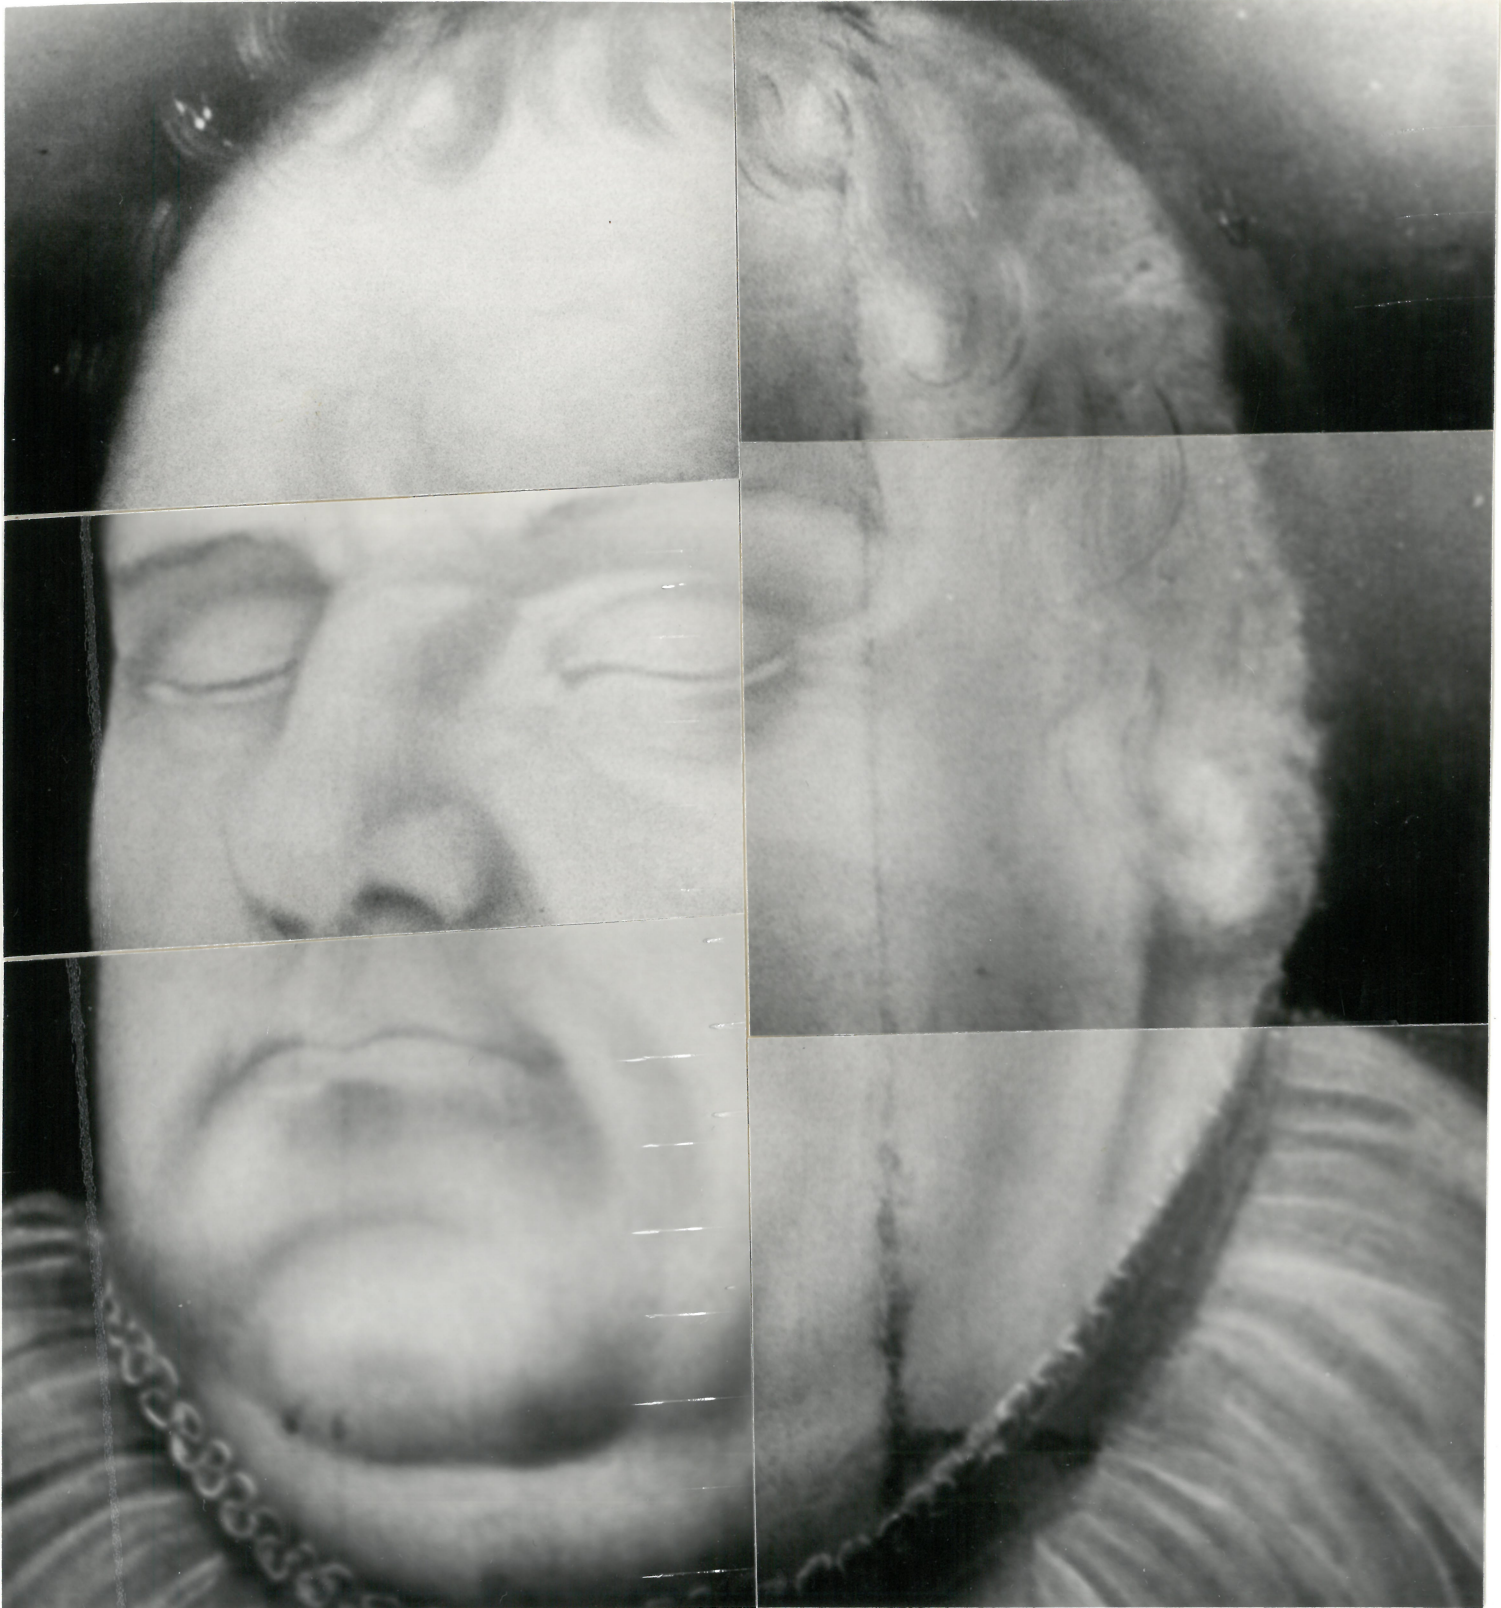
Photo 5.

Infrared reflectogram assembly from the head of Luther, to be compared with photo 4 on page 5. This assembly shows that there is no underdrawing, it also shows the restores crack right from Luther,s left eye. This is an partially overpainted restoration.

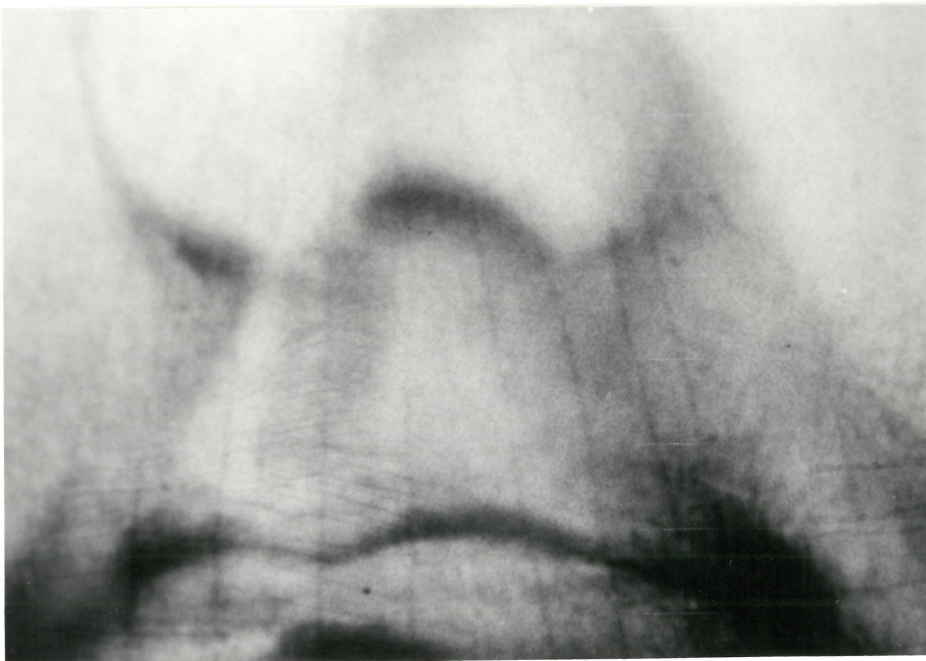
Photo 10.
Infrared reflectogram detail of the mouth of Luther. The dark lines of the craquelure pattern, superimposed by dust in the varnish, give an indication of the age of the painting.

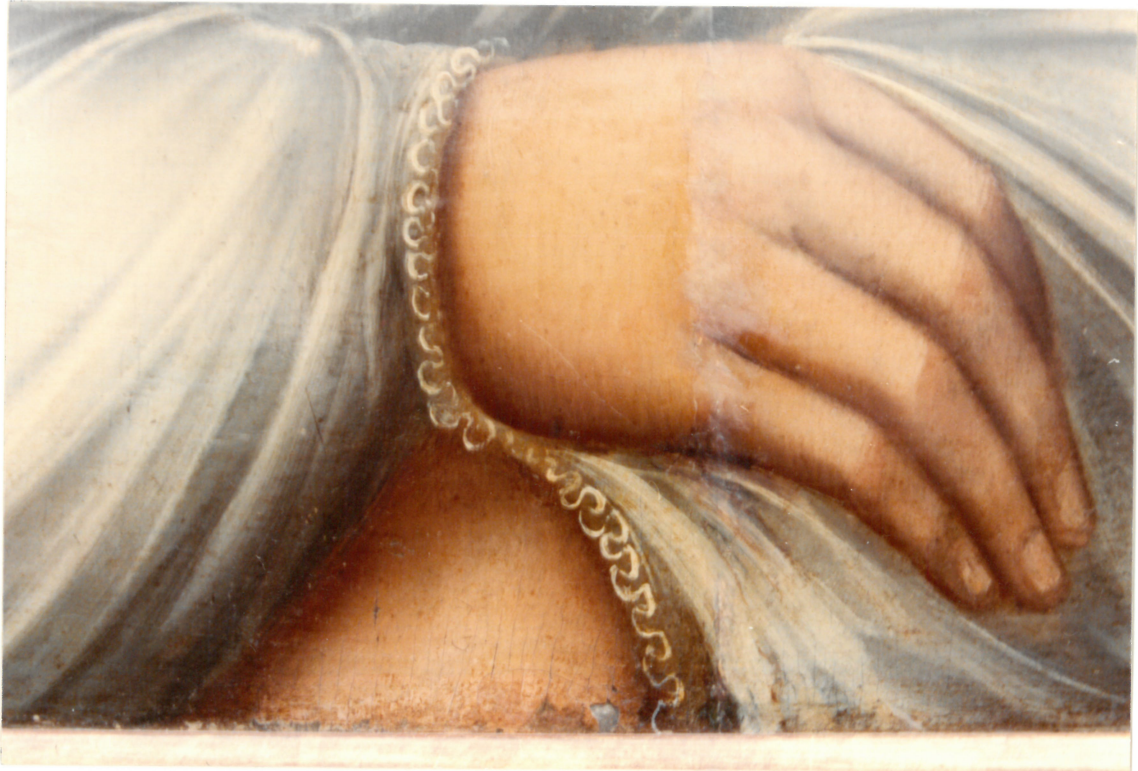
Photo 11.
Normal light photo of the hands of Luther, showing the restored crack over the hands and the paintloss on the bottom (centre) of the painting.

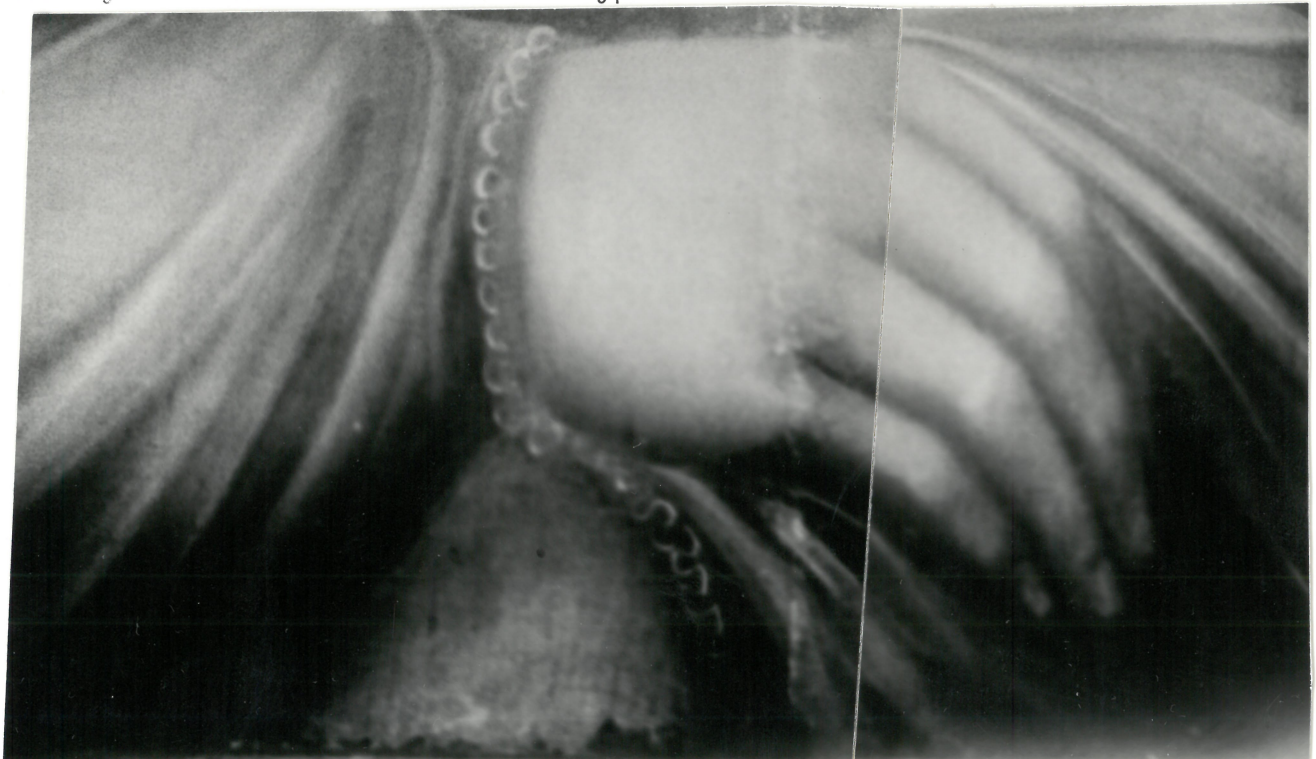
Photo 12.
Infrared reflectogram assembly of the hands of Luther in the bottom of the painting. The restored crack is here visible in white (compare with the crack in photo 5), it clearly shows that this is an other type of restoration.

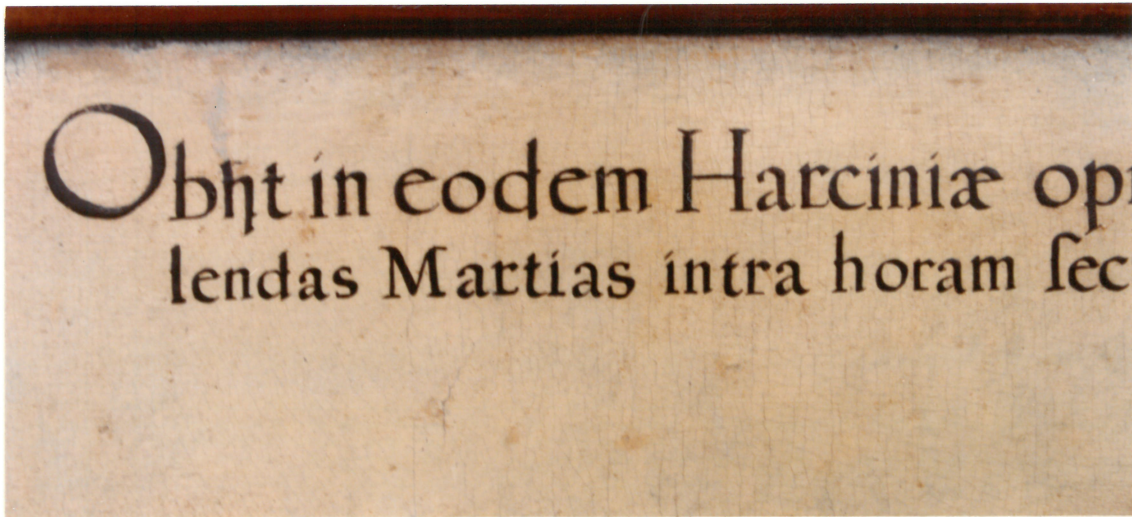
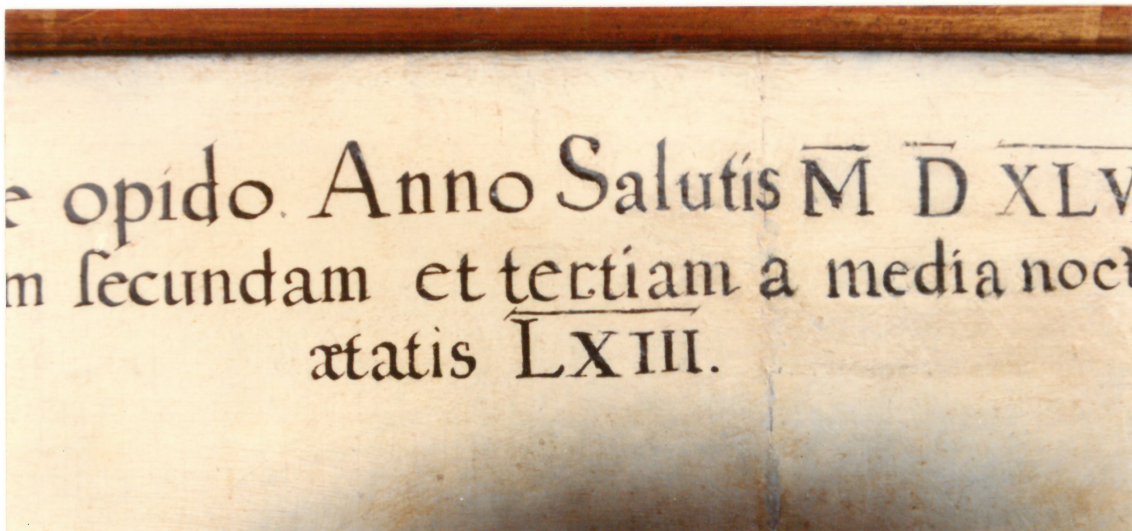
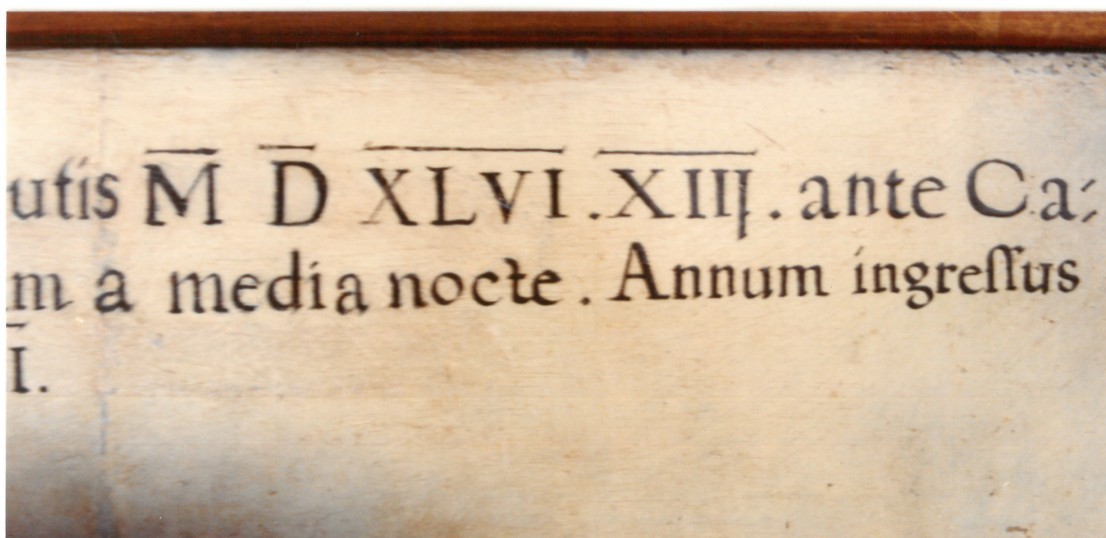
Photo's 16, 17 and 18 are normal light photo's of the text in the upper part of the painting. Except for the part (overpainted) right from the crack, under the text, nothing is restored and/or reinforced.

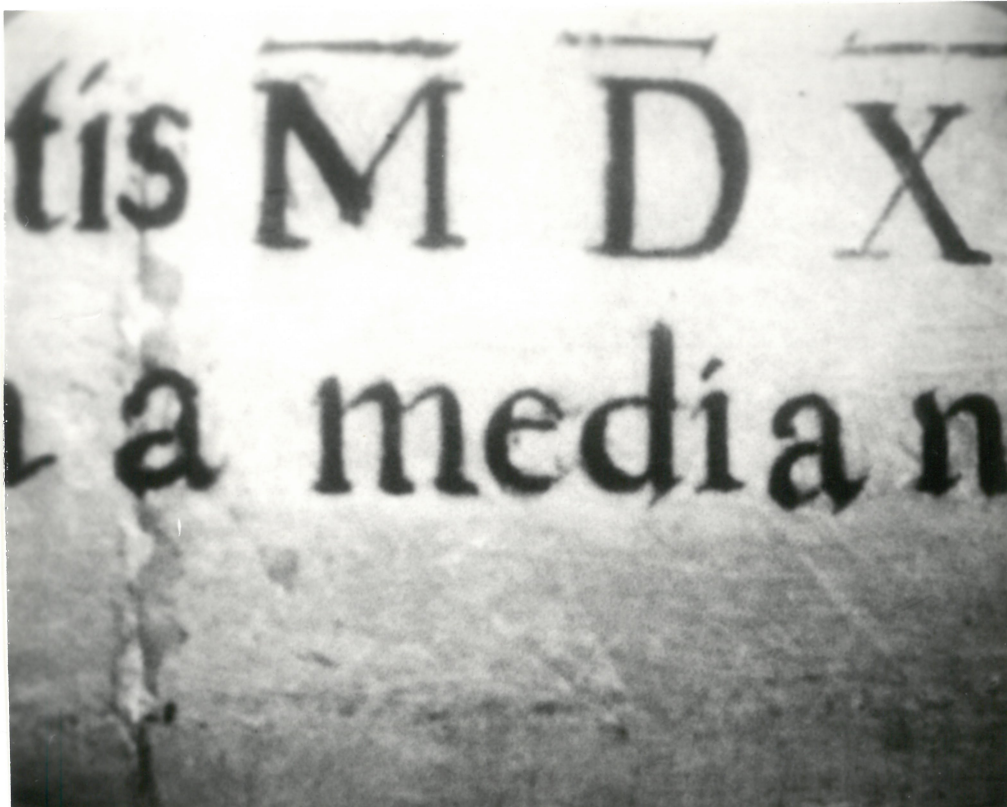
Photo 19.

Infrared reflectogram detail of the text in the upper part of the painting. Compare with the photo's 17 and 18 in the area where the overpainting is visible. In my opinion this has happened when the big crack was restored and can be cleaned away as soon as the painting needs cleaning.

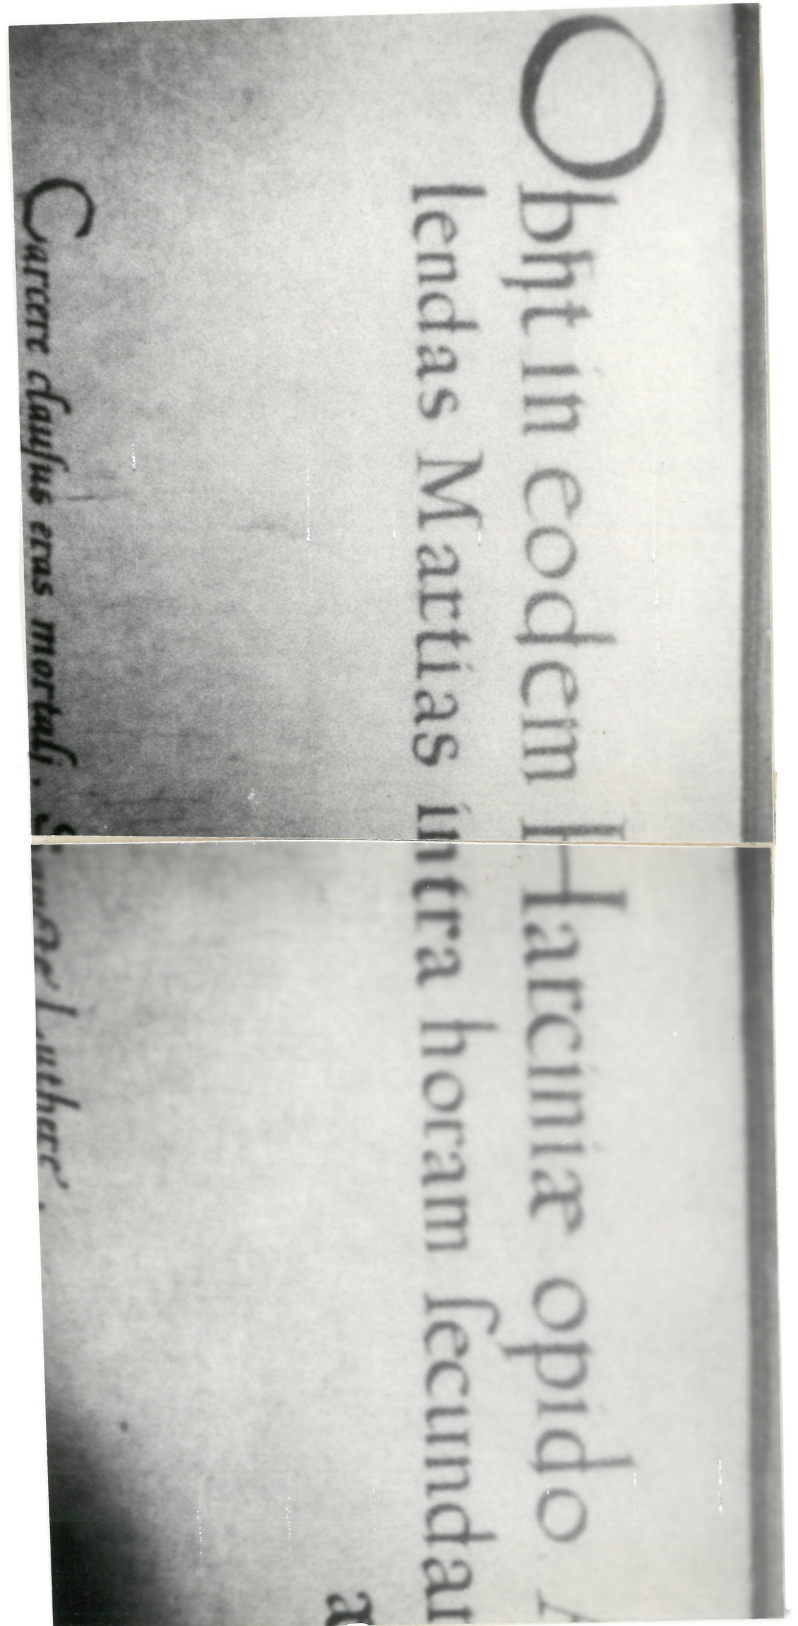
Photo 20.

This is an assembly of infrared reflectograms of the text in the upper part of the painting. It can be compared with the photo's 16, 17 and 18. Also here is shown that no part of the text ever has been restored and/or been reinforced.
