R E S U L T O F E X A M I N A T I O N
=====

of a painting

"Martin Luther in his deathbed"

L u k a s C H R A N A C H d. Ae.
(Kronach 1472 - 1553 Weimar)

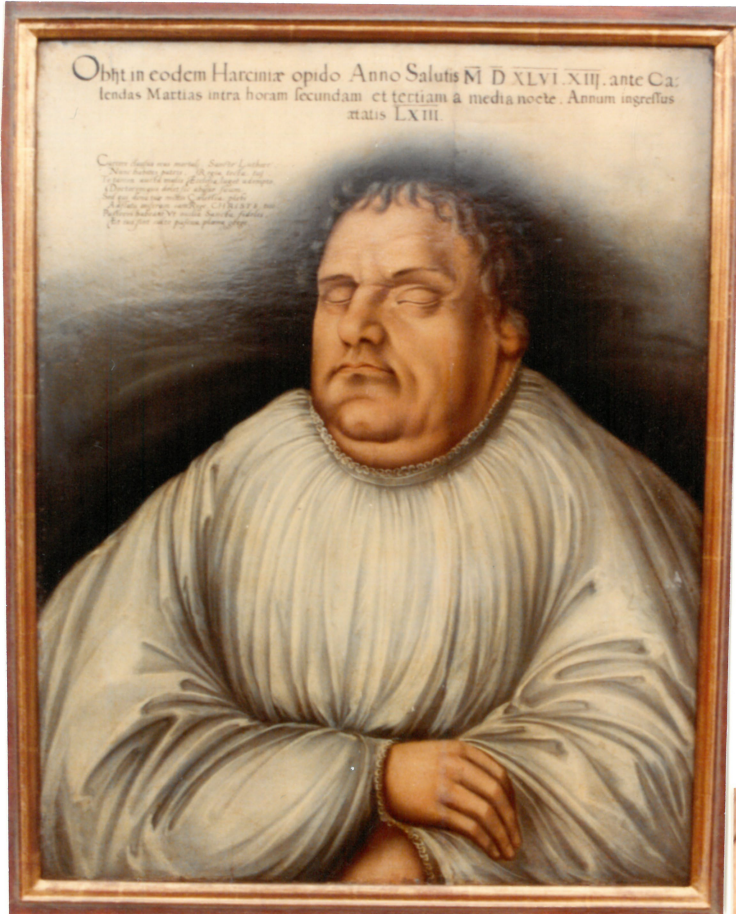
Photo 2.
Normal light photo of the painting.

Photo 3.
Normal light photo of the back of the
painting, showing supporting frame.

Another advise is to remove the cross-laths of the supporting construction, so the panel can work again.

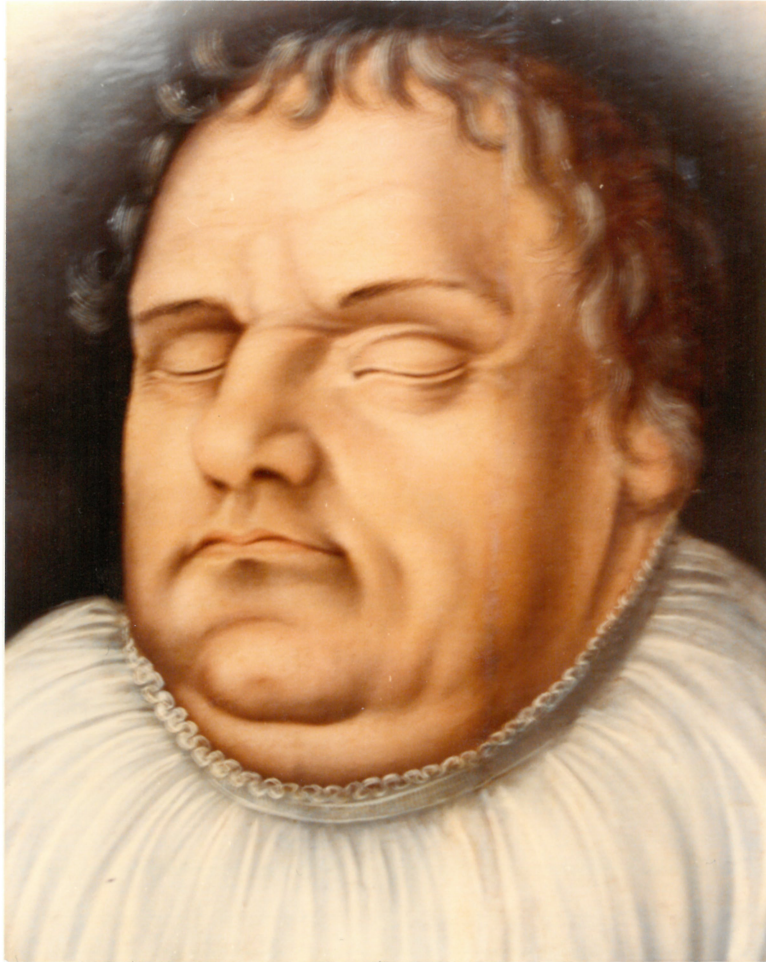
Photo 4.
Normal light detail photo of the head of Luther.

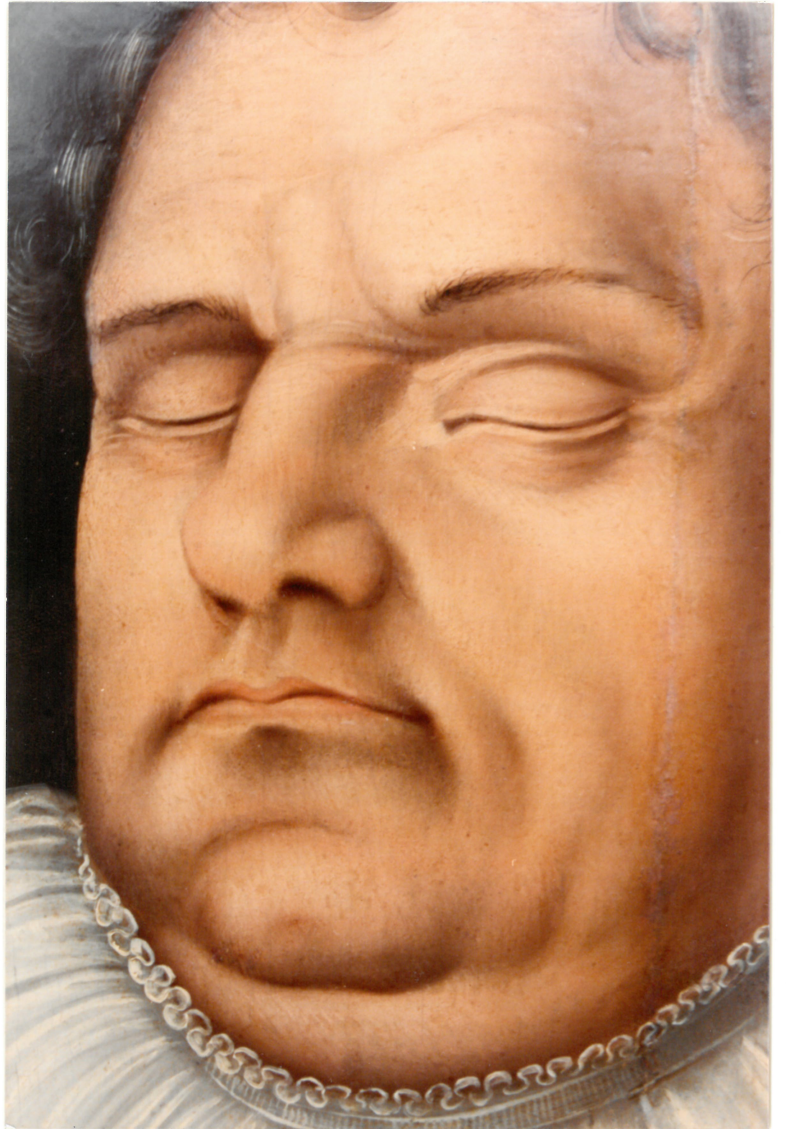
Photo 6.
Normal light detail of the face.

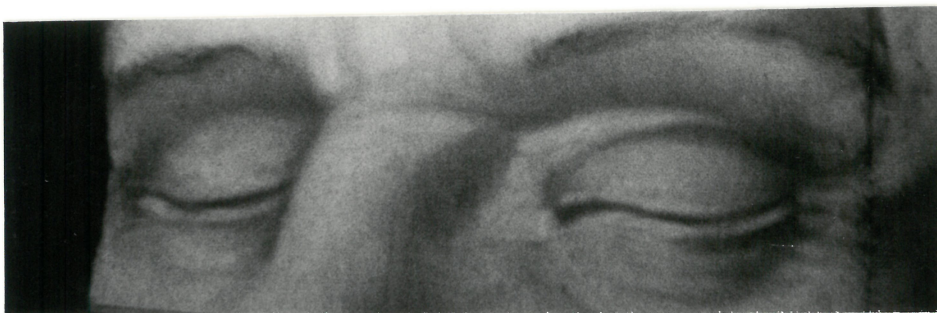
Photo 7.
Infrared reflectogram detail of the eyes of Luther, to be compared with photo 6, 8 and 9.

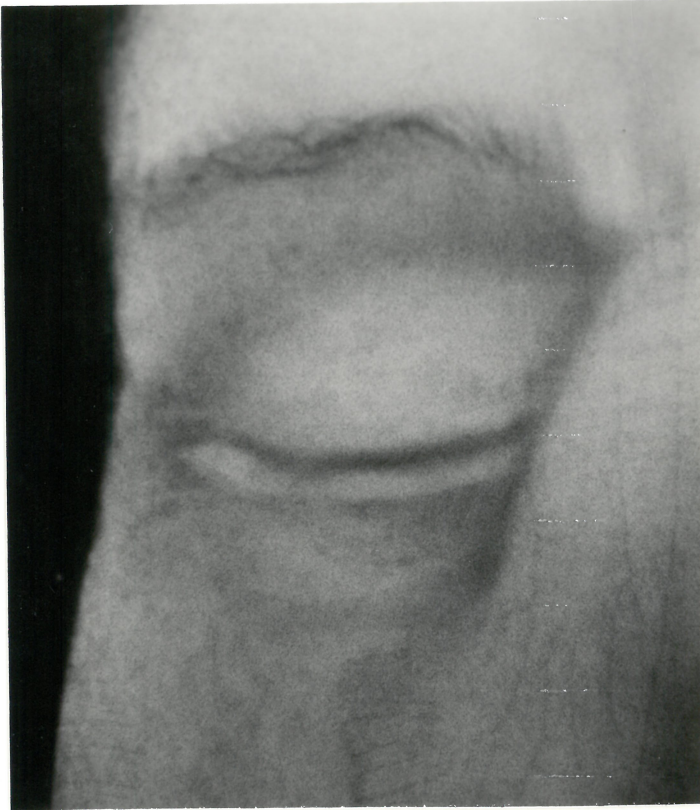
Photo 9.
Infrared reflectogram detail of the right eye of Luther, to be compared with photo 6 and 7. Like in photo 5 there is no visible underdrawing.

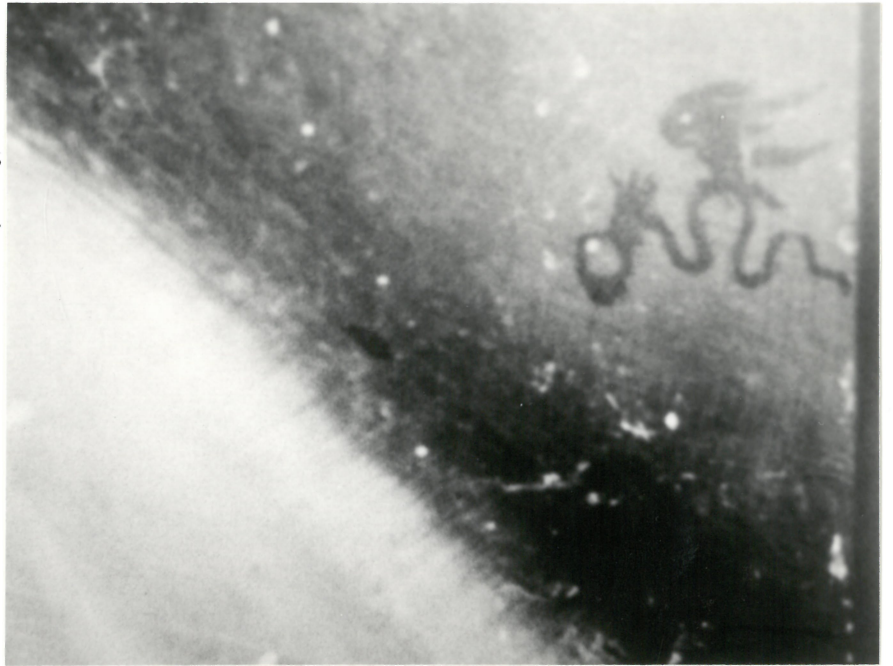
Photo 13.
Infrared reflectogram detail of
the now visible monogram of Lukas
Cranach the Elder (a feathered
ring-carrying snake) in a comple-
tely untouched area.

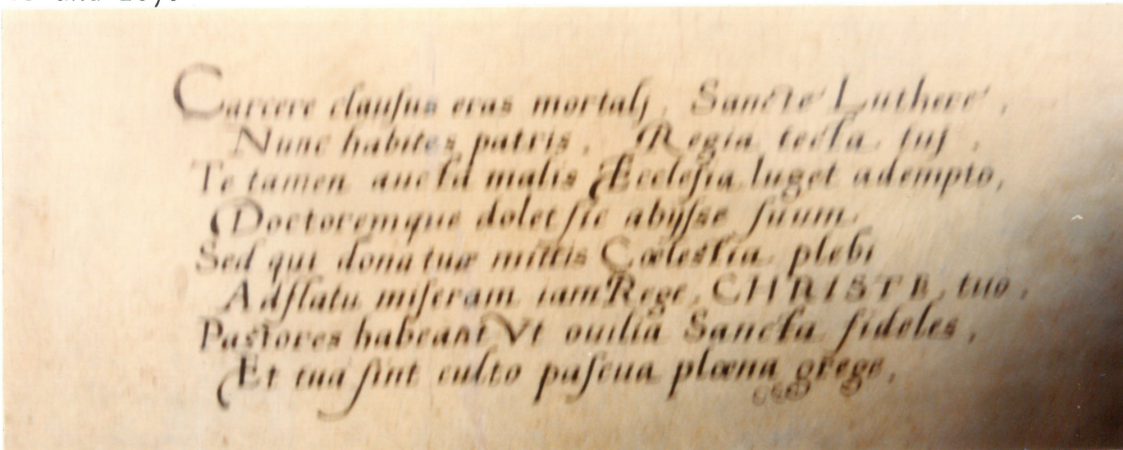
Photo 14.
Normal light photo of the text
left from the head of Luther.
These texts and the other one seem to be original and also untouched (see photo's 17,
19 and 20).

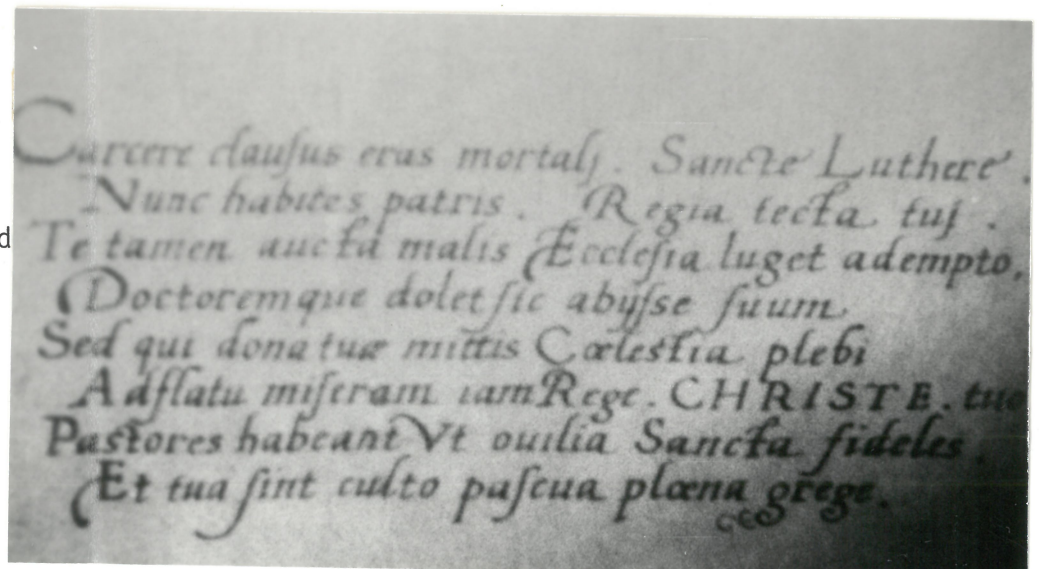
Photo 15.
Infrared reflectogram
detail of the same area
as photo 14.
The text is untouched and
has never been restored.
